Signature Home Inspection

1234 School House Road
Yourtown, US 12345

Prepared for: Bob Smith

Prepared by: Signature Home Inspection
1008 Rose
Highland Heights, OH 44143

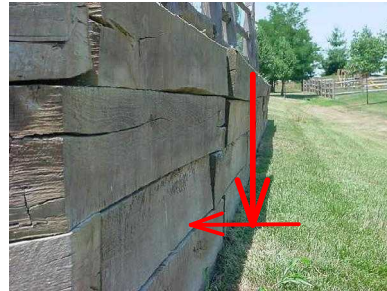
| 8. | <input type="checkbox"/> | <input type="checkbox"/> | <input type="checkbox"/> | <input checked="" type="checkbox"/> | <input type="checkbox"/> | Retaining Walls: Railroad ties The wall is showing signs of movement, but appears to be stable at this time. A qualified contractor is recommended to evaluate and estimate repairs to maintain the wall. |

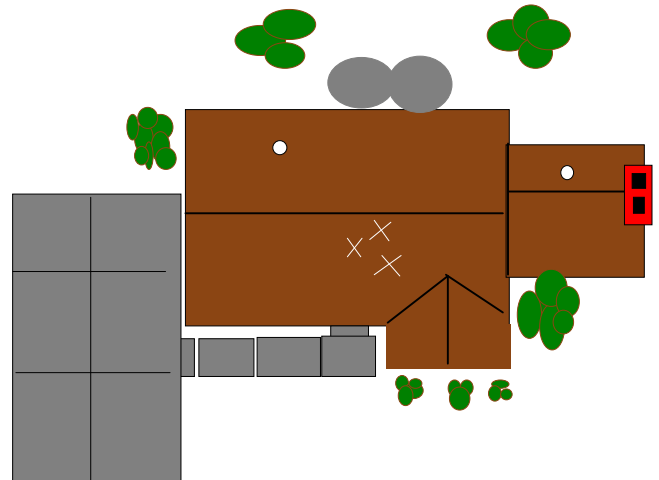
Main Roof Surface

- Method of Inspection: On the roof
- Unable to Inspect: 30% Height of the roof
- Material: Fiberglass shingle Missing roof shingles from wind damage as marked "x" in diagram. Repairs are required.
- Type: Gable

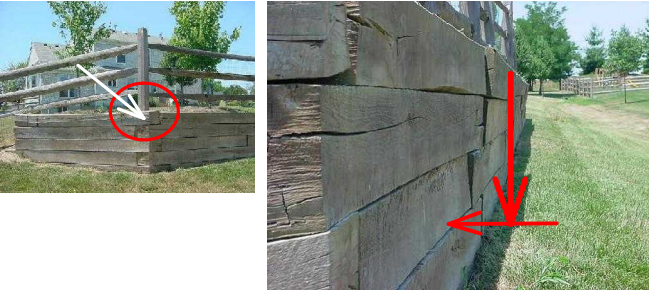
1. Vegetation: Shrubs with some weeds
2. Retaining Walls: Railroad ties The wall is showing signs of movement, but appears to be stable at this time. A qualified contractor is recommended to evaluate and estimate repairs to maintain the wall.
